INVESTIGATION OF FAILURE MODES  
IN A CERAMIC COMPOSITE  
UNDER OFF-AXIS LOADING

THESIS

AFIT/GAE/ENY/89D-9

December 1989

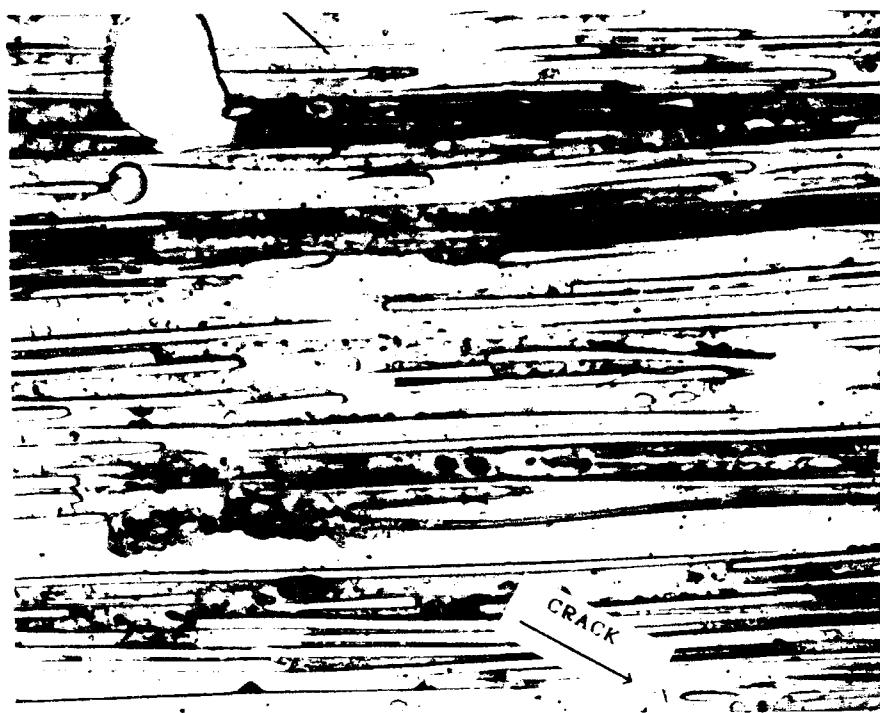
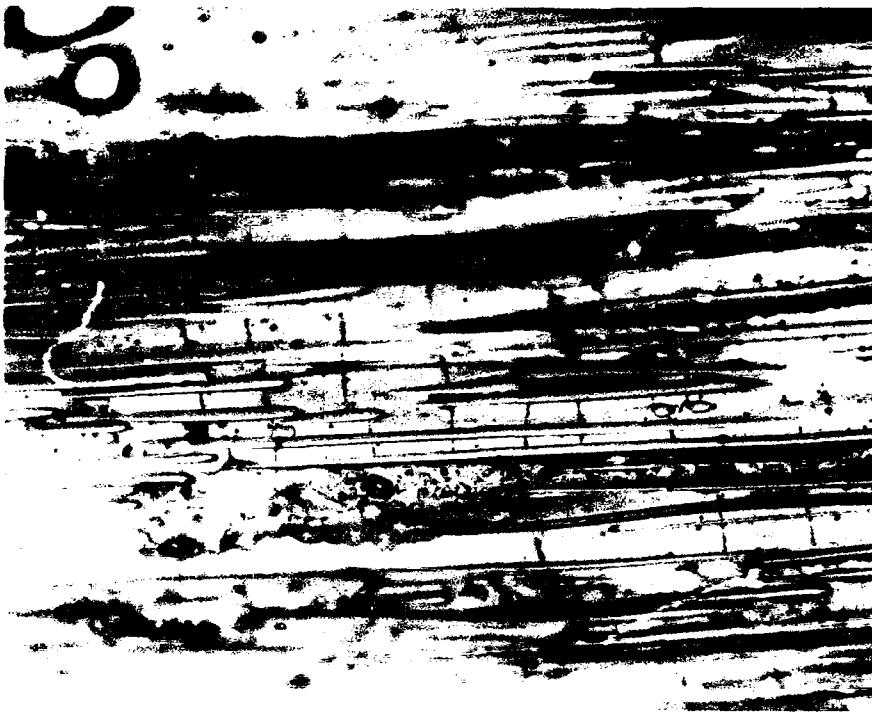
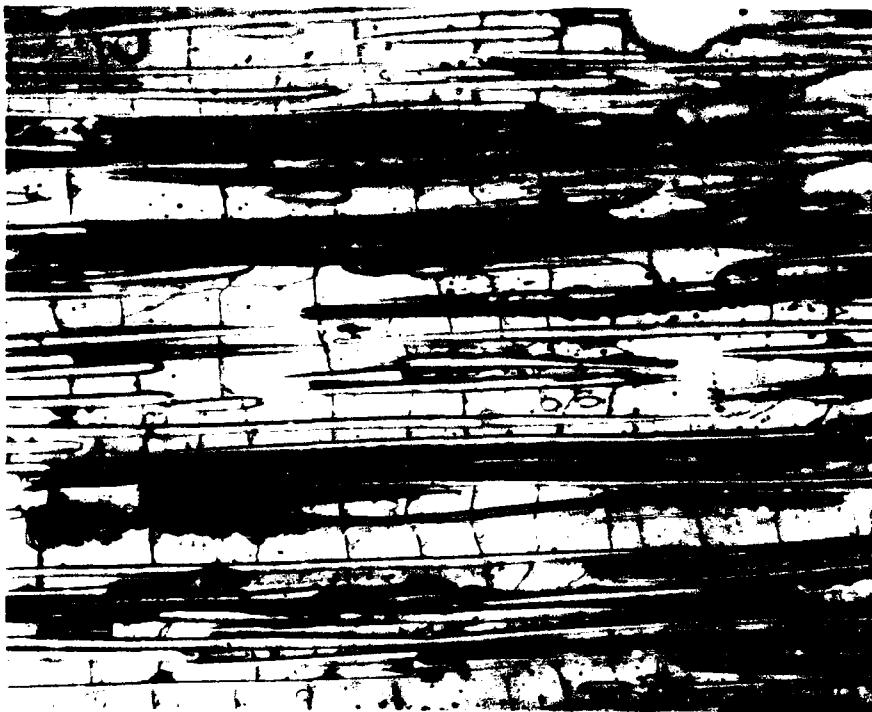
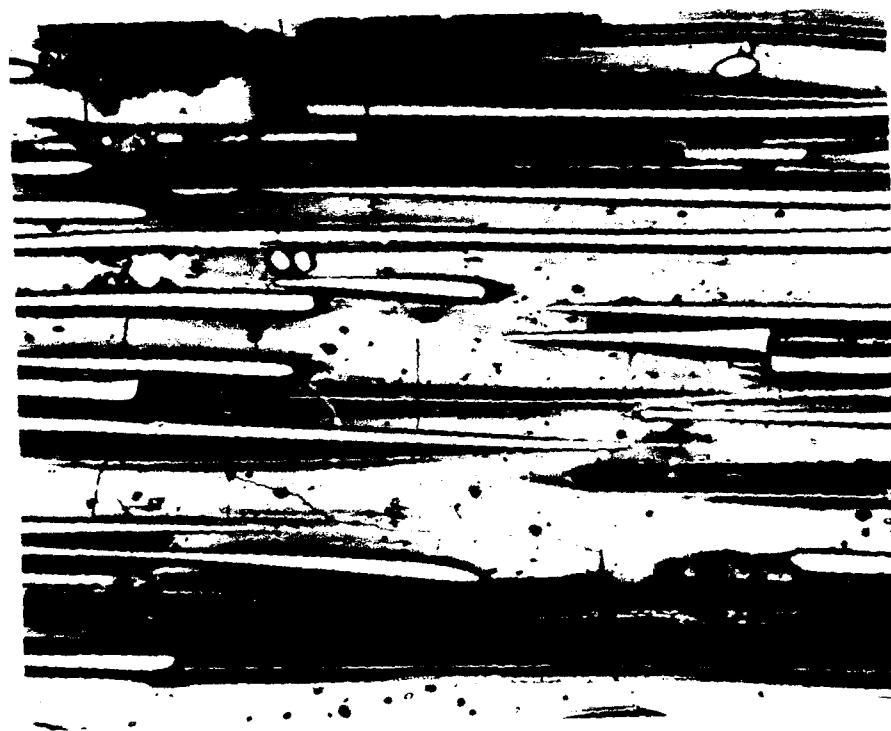
The initial cracking was randomly distributed at first, then became continuous across the edge with increase in load. Figures 13a-e shows how crack spacing changes from loads of 115 MPa to 250 MPa. These pictures were taken at the same spot on the specimen. Figure 13a shows an initial crack in the right hand corner when the stress was 115 MPa. Figure 13b shows two small cracks in the right hand corner when the stress was 160 MPa. Then the cracking becomes more continuous through the edge and crack spacing is more even, as seen in Figure 13c at 218 MPa. Figure 13d shows the crack spacing decreases further at 250 MPa. Finally, at failure Figure 13e shows the crack spacing is the same as seen in the previous picture. The matrix crack density will be further discussed in a later section of this chapter. Since the matrix cracking begins in the linear portion

(a) Edge at 115 MPa (100x)

(b) Edge at 159 MPa (100x)

Figure 13 Crack Progression for 0 Degree Specimen (115-250 MPa)  
Specimen 0-2

(c) Edge at 218 MPa (100x)

(d) Edge at 250 MPa (100x)

(e) Edge at 254 MPa (Failure) (200x)

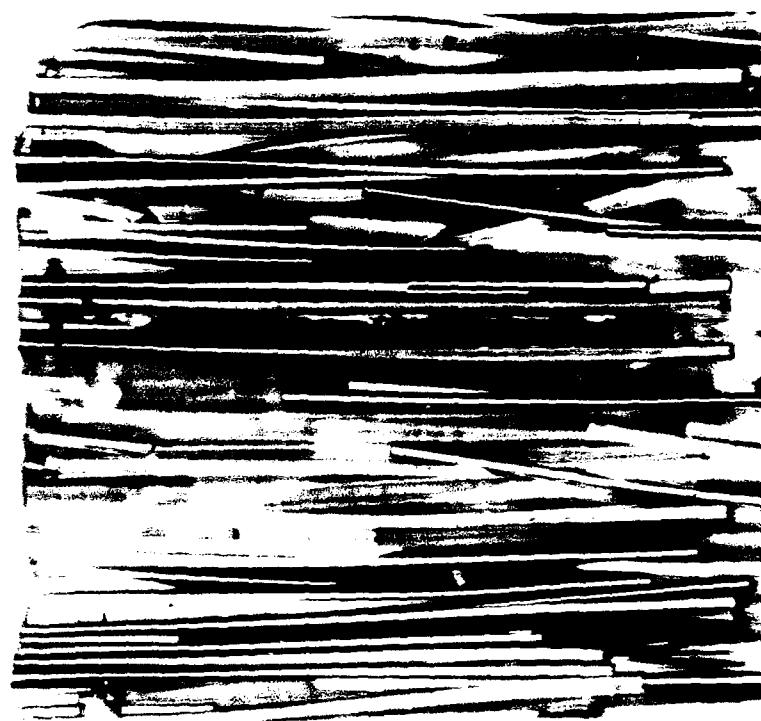
Figure 16 Fracture Surface of 0 Degree Specimen (100x)

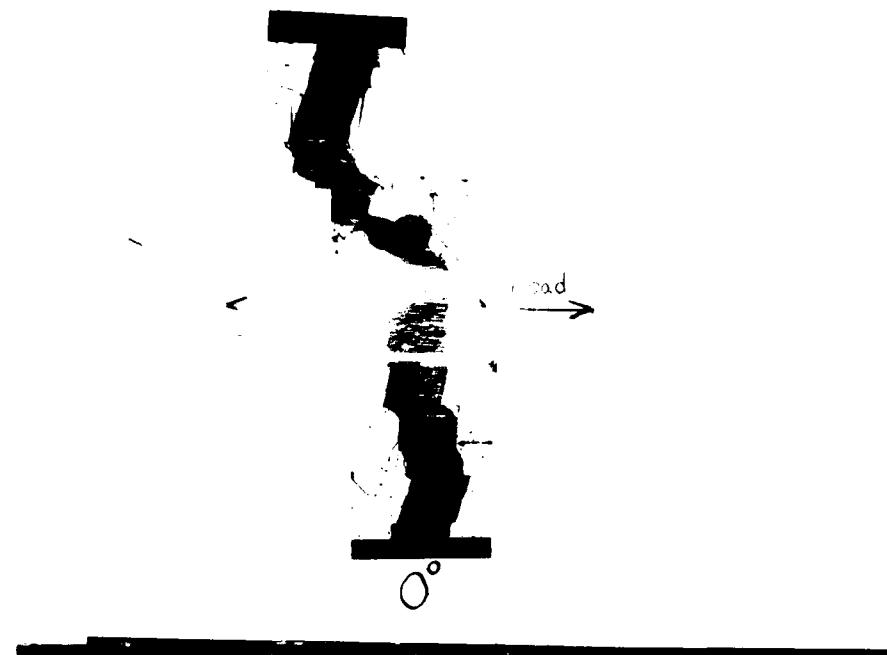
Figure 17 Fracture Surface across Width and Thickness for 0 Degree Specimen

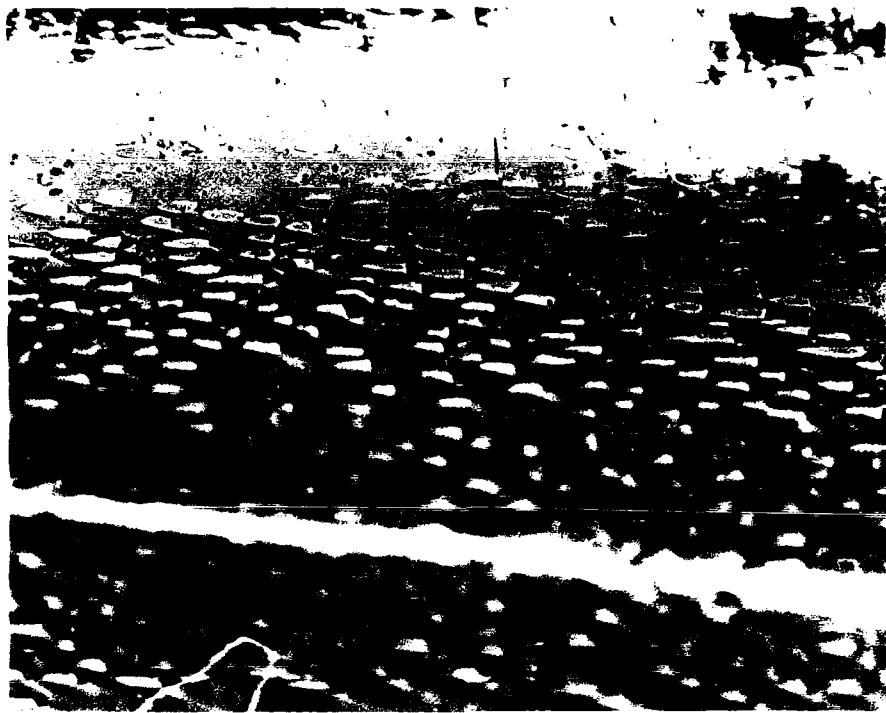
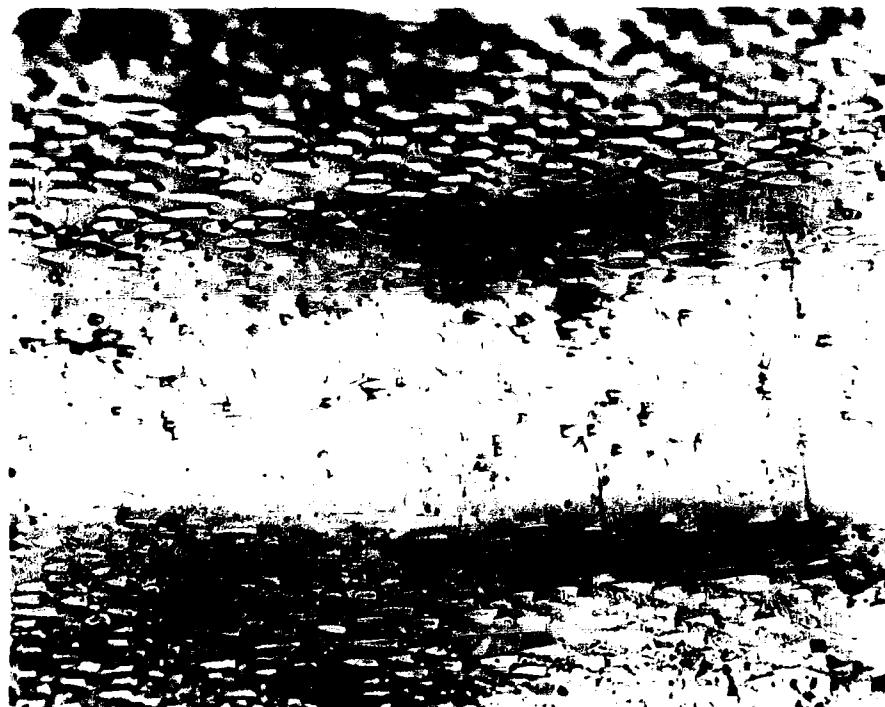
(a) Edge at 92 MPa (100x)

(b) Edge at 113 MPa (100x)

Figure 19 Crack Progression for 15 Degree Specimen

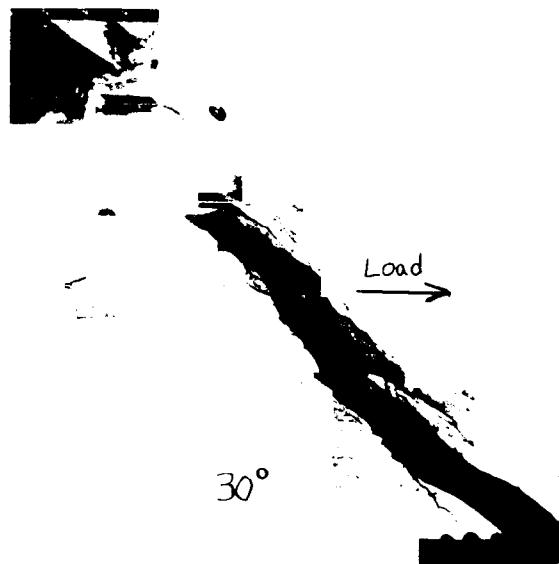
The average ultimate stress and strain for this orientation was 72.1 MPa and 576  $\mu\epsilon$  respectively. The final failure through the width was in the direction of the fibers, 30 degrees off the direction of the load, see Figure 24 and 25. Figure 25 shows minimal fibers protruding from the edge of the final crack interface. This means the fiber did very little of the load carrying after the matrix started to fail.

Figure 24 Fracture Surface across Width and Thickness for 30 Degree Specimen
